KOMER LAKE DAM

BUCHANAN COUNTY, MISSOURI

MO. 10995

PHASE 1 INSPECTION REPORT NATIONAL DAM SAFETY PROGRAM

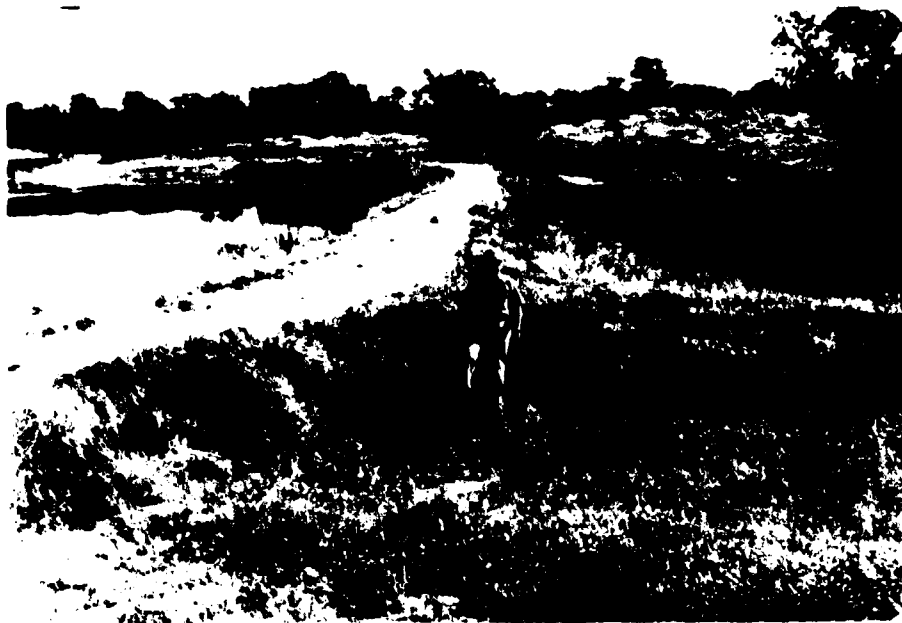
Materials in the dam are silty loess (CL-ML). The soil deposits in the dam area consist of upland soils of the Sharpsburg-Grundy-Adair-Shelby soil association. This soil association is common in a landscape in which moderately deep loess overlies glacial till.
 - (2) Upstream Slope. The upstream slope is fairly well vegetated with grass and small willows. No slumping or significant erosion was noted on the upstream slope. Photo No. 4 shows the upstream slope.
 - (3) Crest. The crest is sparsely vegetated and serves as a dam road. Measurements indicate that the crest elevations are relatively uniform with a slightly lower area toward the right end of the dam (See Plate C-1). No cracks or slumps were noted on the crest. Photos 3 and 6 show the crest.

- (4) Downstream Slope. The downstream slope is fairly well vegetated with grass and weeds as shown in Photos 6 and 9. Considerable erosion was noted on the slope as shown in Photo 13. No cracks, slides or slumps were evident on the slope. Gully erosion and headcutting were observed in both abutment troughs as shown in Photos 5 and 9. Seepage outcrops in both abutment troughs and along the toe of the dam. Seepage in the left abutment trough outcrops at about elevation 976, about 4 feet lower than the reservoir level. Seep in the right abutment trough outcrops at about elevation 955, some 10 feet above the valley floor. Seepage is through gravelly, till-like material. All seepage is clear, and there were no indications of boils. The total seepage discharge is estimated at less than 1 g.p.m. Seepage discharges are shown in Photos 14, 17 and 18.

PHOTO NO. 6 - CREST OF DAM TAKEN FROM RIGHT END. FOOT ON TOP OF BARREL EMERGENCY SPILLWAY.

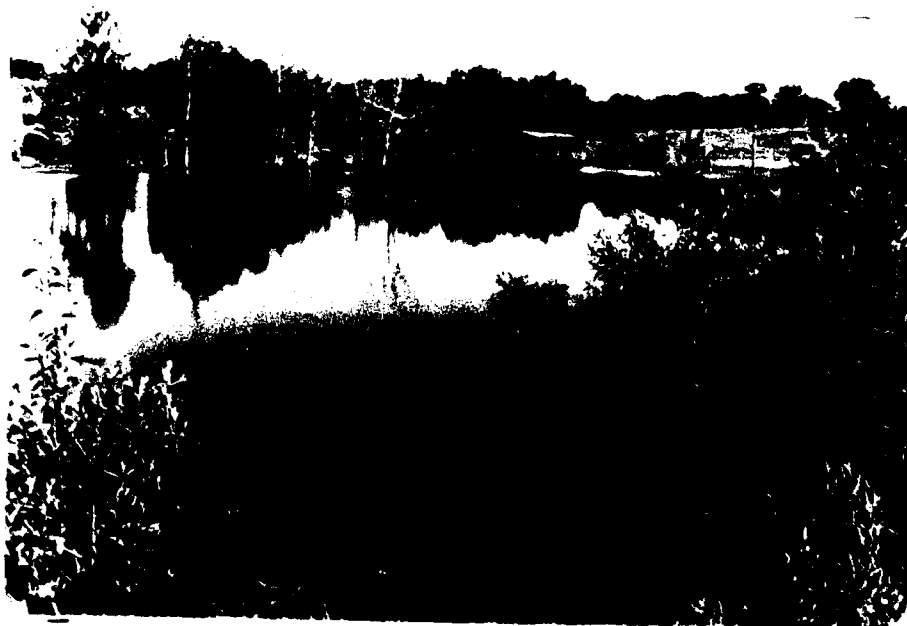
- d. Reservoir Area. The reservoir area is fairly well vegetated around the water line. No slumps, slides or severely eroded areas were observed around the shoreline. Photo 11 shows a portion of the reservoir.
- e. Downstream Channel. The channel downstream from the pipe spillway is badly clogged with trees and brush. However, this growth should not interfere with discharges from this small pipe spillway. Photo 12 shows the valley downstream from the pipe spillway.

PHOTO NO. 11 - VIEW UPSTREAM TAKEN FROM PRINCIPAL SPILLWAY LOCATION.

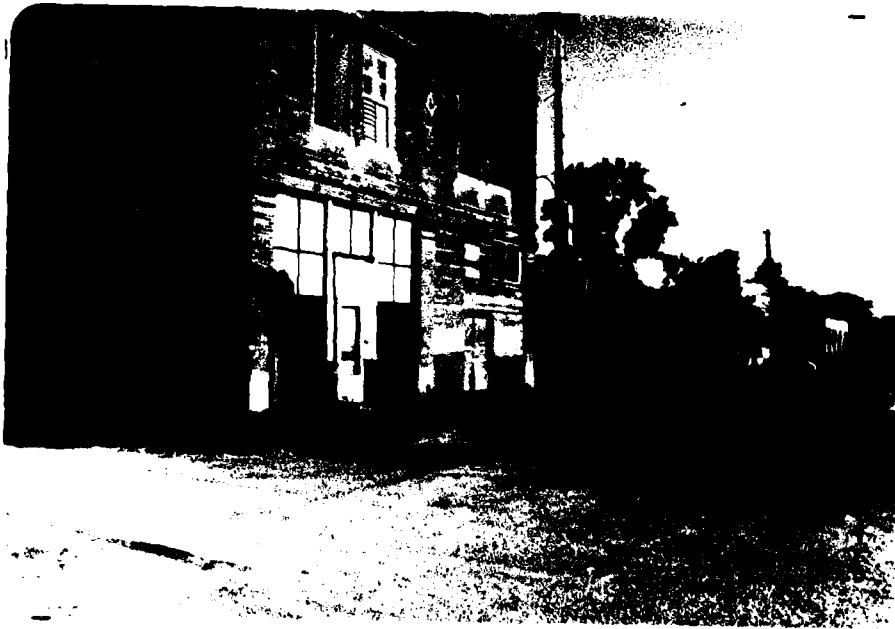
PHOTO NO. 20 - BUILDING IN AGENCY. NOTE HIGH WATER MARKS. HIGH WATER MARKS RESULT FROM FLOODS ON THE PLATTE RIVER NOT THE USSARY AND KOMER TRIBS.
